Why the trellis needs to be installed by end of Yr 1

Why Machined Vine Planting Must Be Done With Great Care And Skill

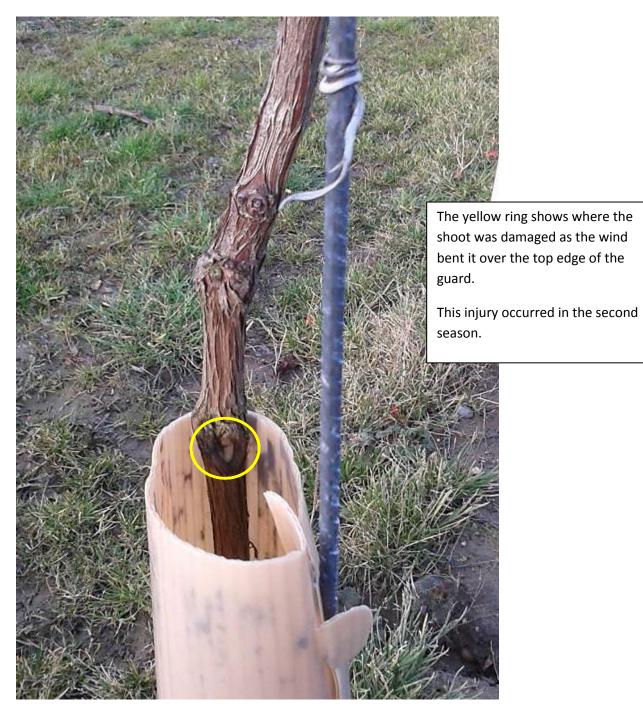
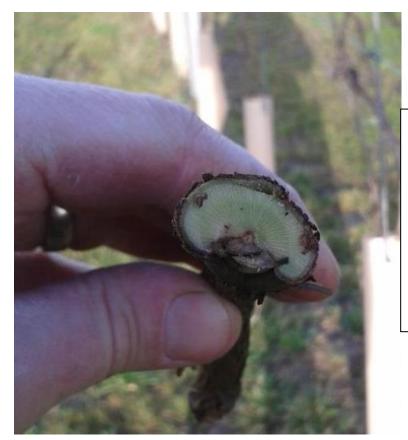
The injury to the shoot has broken through the protective cambium layer, resulting in death of the vascular tissue inside the trunk.

Vine performance is dramatically affected, as this dead tissue significantly reduces the capacity for transport of moisture and nutrients up into the vine.

The trunk must therefore be cut back down, until no dead tissue is visible.

The vine will need to be reestablished, by using a water shoot to create a new trunk.

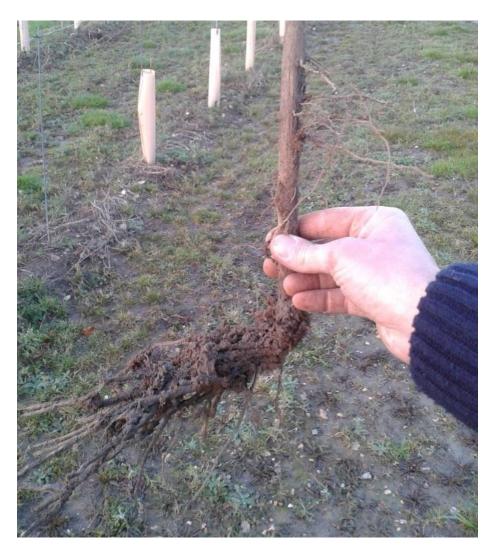
Classic 'J' Rooting. This vine has failed to establish, as a result of:

- Roots not being trimmed to length
- Planting machine being driven too fast
- Workers not taking time to set depth of plants when placing in the planting machine
- Workers not taking time to check the depth of plants in the ground, once planted
- Vines therefore planted too low, with the long roots trailing on along the bottom of the cavity created by the machine. Almost no extra root growth produced in three years.
- Adventitious roots have been produced further up the rootstock stem as a reaction by the vine to the decline of the main root system.
- This could have been avoided by root trimming and control of planting depth.
